# VERDE RIVER WATERSHED REPORT CARD 2025

— SUMMARY —

# 2025 VERDE WATERSHED REPORT CARD

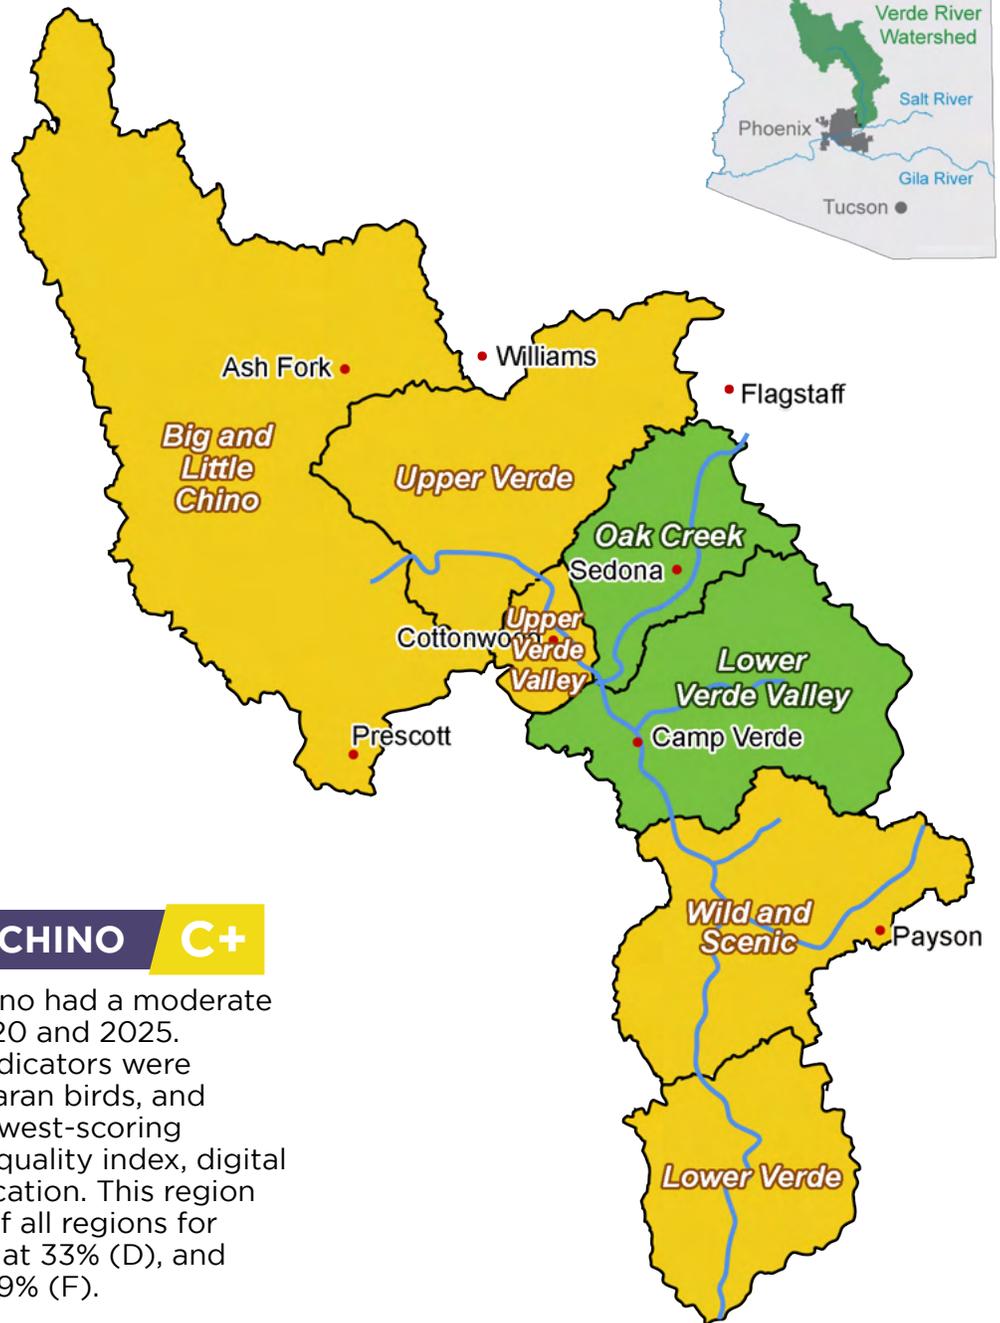
**REGION 1** **BIG AND LITTLE CHINO** **C+**

The Big and Little Chino had a moderate score, 53% (C+), in 2020 and 2025. The highest-scoring indicators were visitor satisfaction, riparian birds, and unemployment. The lowest-scoring indicators were water quality index, digital engagement, and education. This region had the lowest score of all regions for depth to groundwater at 33% (D), and water quality index at 9% (F).

**REGION 2** **UPPER VERDE** **C+**

The Upper Verde had a moderate score, 54% (C+), which is an improvement from 51% (C+) in 2020. The highest-scoring indicators were visitor satisfaction and riparian birds. The lowest-scoring indicators were recreation access, digital engagement, and macroinvertebrates. This region had the lowest score in the watershed for digital engagement and recreation access at 0% (F), likely due to the low human population numbers and remote nature of this region.

**REGION 3** **UPPER VERDE VALLEY** **C+**

The Upper Verde Valley Region had a moderate score of 54% (C+) in 2025, similar to the 2020 score of 55% (C+). The lowest-scoring indicators were water quality index (0%, F) and digital engagement (2%, F). Indicators with A+ scores included water quality certainty, riparian birds, visitor satisfaction, and recreation access. This region had the lowest baseflow score at 30% (D).

**REGION 4**

**OAK CREEK**

**B**

In both 2020 and 2025, Oak Creek was the highest scoring region in the watershed, with a score of 67% (B) (65% in 2020). The region had A+ scores in recreation access, visitor satisfaction, digital engagement, and water quality certainty. This region had the lowest score for education and affordable housing in the watershed.

**REGION 5**

**LOWER VERDE VALLEY**

**B-**

The Lower Verde Valley score remained stable, increasing only slightly from 62% in 2020 to 63% (B-) in 2025. This region scores very high in recreation indicators, including recreation planning, access, and visitor satisfaction. The region also has high scores in water quality certainty, riparian birds, and low unemployment rates. The lowest scores in this region were from macroinvertebrates (D-) due to low sampling size, and digital engagement (D-). This region has the highest score for civic engagement in the watershed (B+).

**REGION 6**

**WILD AND SCENIC**

The Wild and Scenic score increased from 54% (C) in 2020 to 64% (B-) in 2025. Since 2020, increases in scores were seen for water quality certainty, upland habitat, and recreation, highlighting the improved recreation planning since 2020. The highest scores in this region come from riparian birds, unemployment, and recreation indicators. This region has the lowest score in the watershed from civic engagement, highlighting the need for additional outreach.

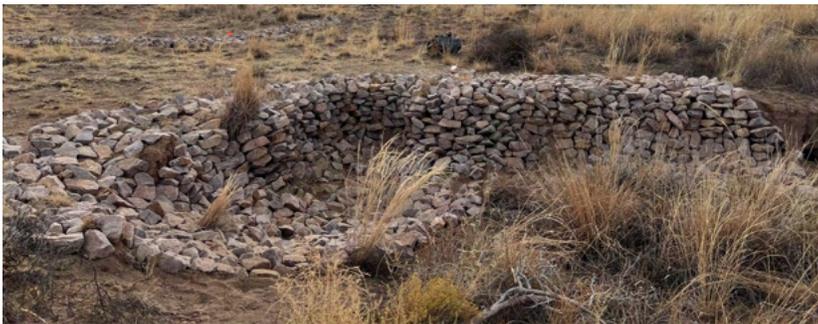
## PROJECT HIGHLIGHTS MUNDS DRAW

Humans created changes to the landscape, including unauthorized, user-created roads and overgrazing, can lead to accelerated erosion and gully formation. Process-based restoration heals the landscape by mimicking naturally occurring hydrologic processes. By understanding how water will flow, we can install structures to slow the water down, allowing sediments to settle and regrade incised systems. This keeps soil and water on the landscape - building resiliency, reducing erosion, improving wildlife habitats, and reducing sedimentation downstream.

The Prescott National Forest identified Munds Draw as a priority subwatershed in need of upland restoration and brought this project to VWRC. Project implementation began in 2020 and included juniper thinning in grassland habitats and installing rock structures and juniper slash into gullies to reduce erosion. Since the 2020 Report Card, restoration crews and volunteers have installed, repaired and monitored 288 structures, and thinned 575 acres at the Munds Draw site.

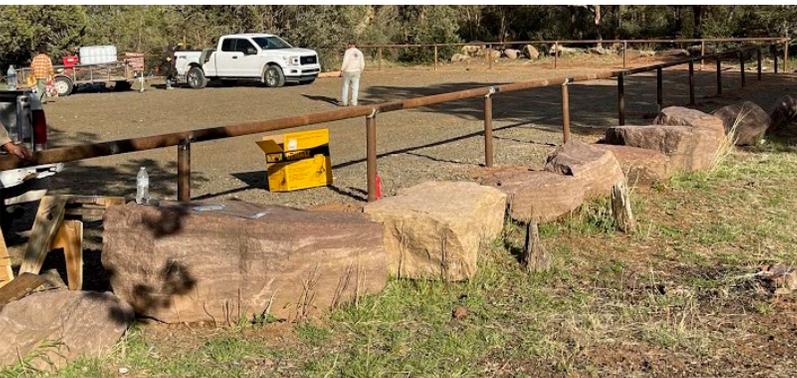
## FLOWING SPRINGS

The Flowing Springs project on the Tonto National Forest involved installing pipe rail fencing to close a riparian and upland area to vehicles. This area was experiencing gullying and habitat degradation. The first step in a restoration project is to remove the stressor, in this case the vehicles. Now that the stressor is removed VWRC partners will work to identify next steps.

Gully Busters is a community science program developed by VWRC, and led by Friends of the Verde River and Coconino National Forest. Community scientists collect data about accelerated erosion on the landscape. Their data informs land management decisions and identifies locations for erosion control structures.
